## **Inspection Report Minerals Regulatory Program**

Mine Name: Bin	gham Canyon Mine
<b>Operator Name:</b>	Kennecott Utah Copper

Permit number: M/035/002 **Inspection Date:** May 23, 2006

Check the progress of the reclamation of the 5990 level of the Bingham Canyon Waste Dump and check the progress of the recontouring of the Queen Dump.

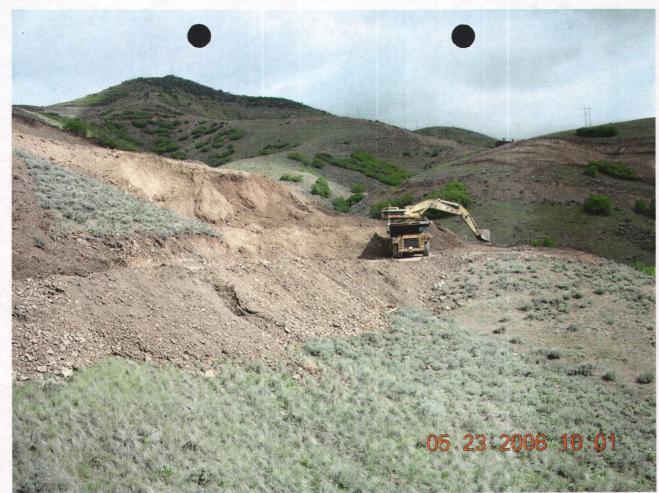
KUC Bingham Canyon 6190 Soil Recovery 006.jpg 2006/05/23 10:01:30

They are presently in the process of stripping soil from areas at the base that will be impacted when this portion of the dump is regraded to the planned 2.75:1 slope. Soils removed from the areas at the base of the dump are being stockpiled near the base. Soils being stripped from the areas above which will be impacted by the next level (6190) are being placed on the top of the 5990 level and will be used as soil cover on the face of the 5990 level after it has been regraded. Photos were taken of this operation and are included in this report.

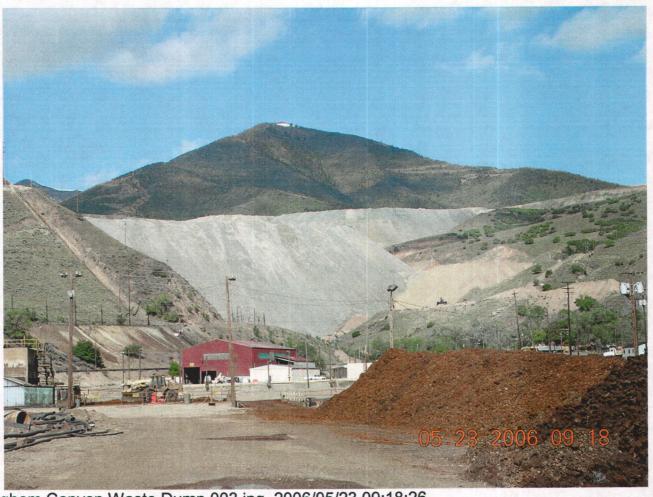
KUC Bingham Canyon Waste Dump 003.jpg 2006/05/23 09:18:26

As each level of the dump are complete it will be regraded, covered with between 18 to 36 inches of soil, and revegetated. The 5990 level of the dump has been completed and KUC is preparing to initiate the regrading of this portion.

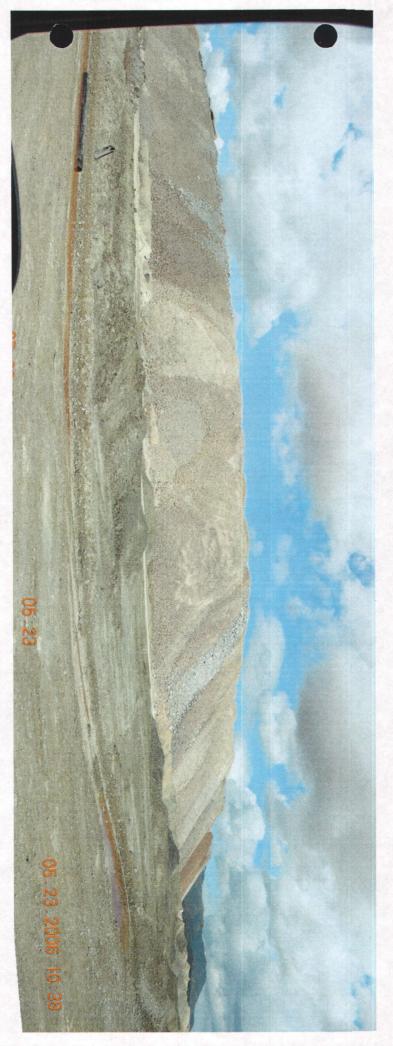
OXIDE MATERIAL DUMP

The next area inspected was the waste dump area where the oxidized cap material from the pre-stripping for the Giant Leap expansion is being stored. Pre-stripping for the Giant Leap is on

going and material is being moved to this area to be used to be used to cap several of the acidic dumps in the area.

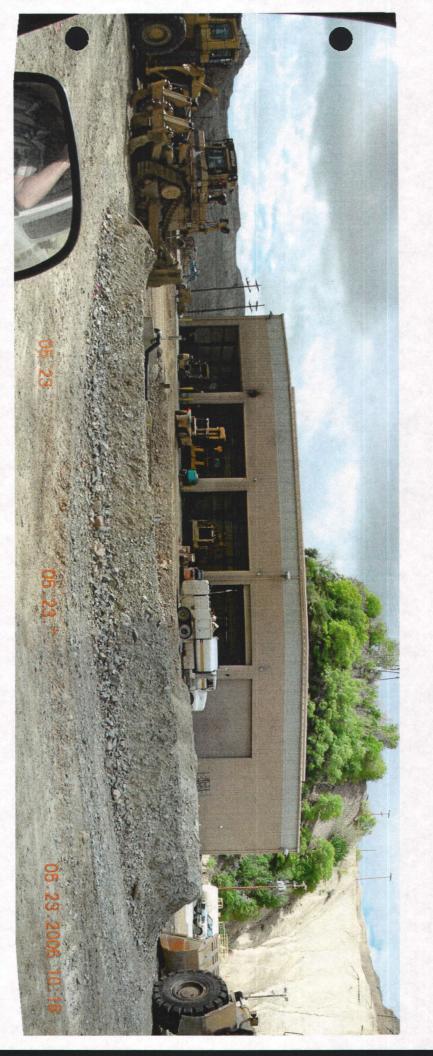
AUXILLARY SHOP

The next area visited was the new shop area. Portions of the shops have been relocated due to the planned Giant Leap expansion. The shell of the main shop building appears to be about 70 to 80% complete, the auxiliary shop has been completed and is presently in use.

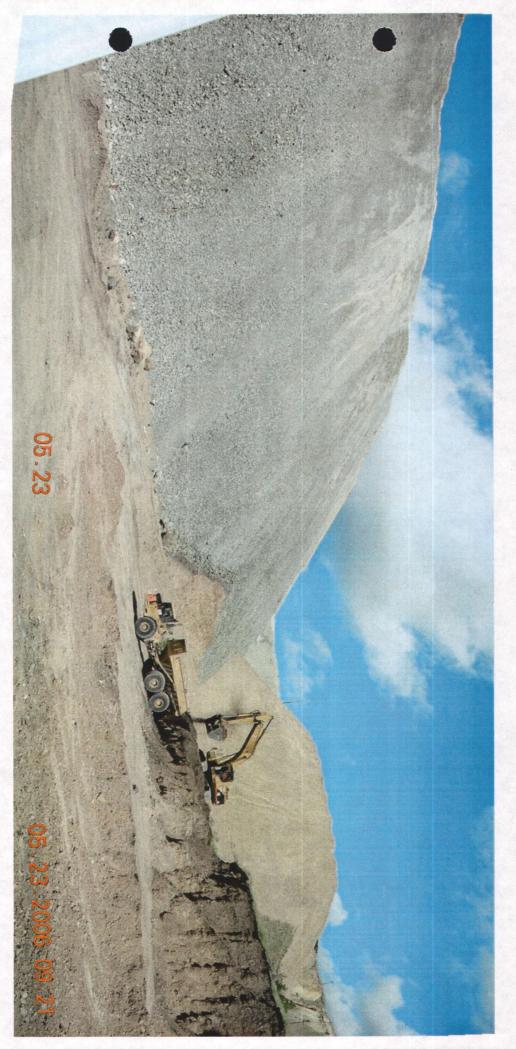
BINGHAM CANYON WASTE DUMP SOIL RECOVERY FRIOR TO RESCOPING EFFORT
